# CITY OF PIQUA, OHIO

## INFLOW AND INFILTRATION INVESTIGATION AND SEWER SYSTEM EVALUATION SURVEY PLAN

FINAL REPORT

OCTOBER 2006

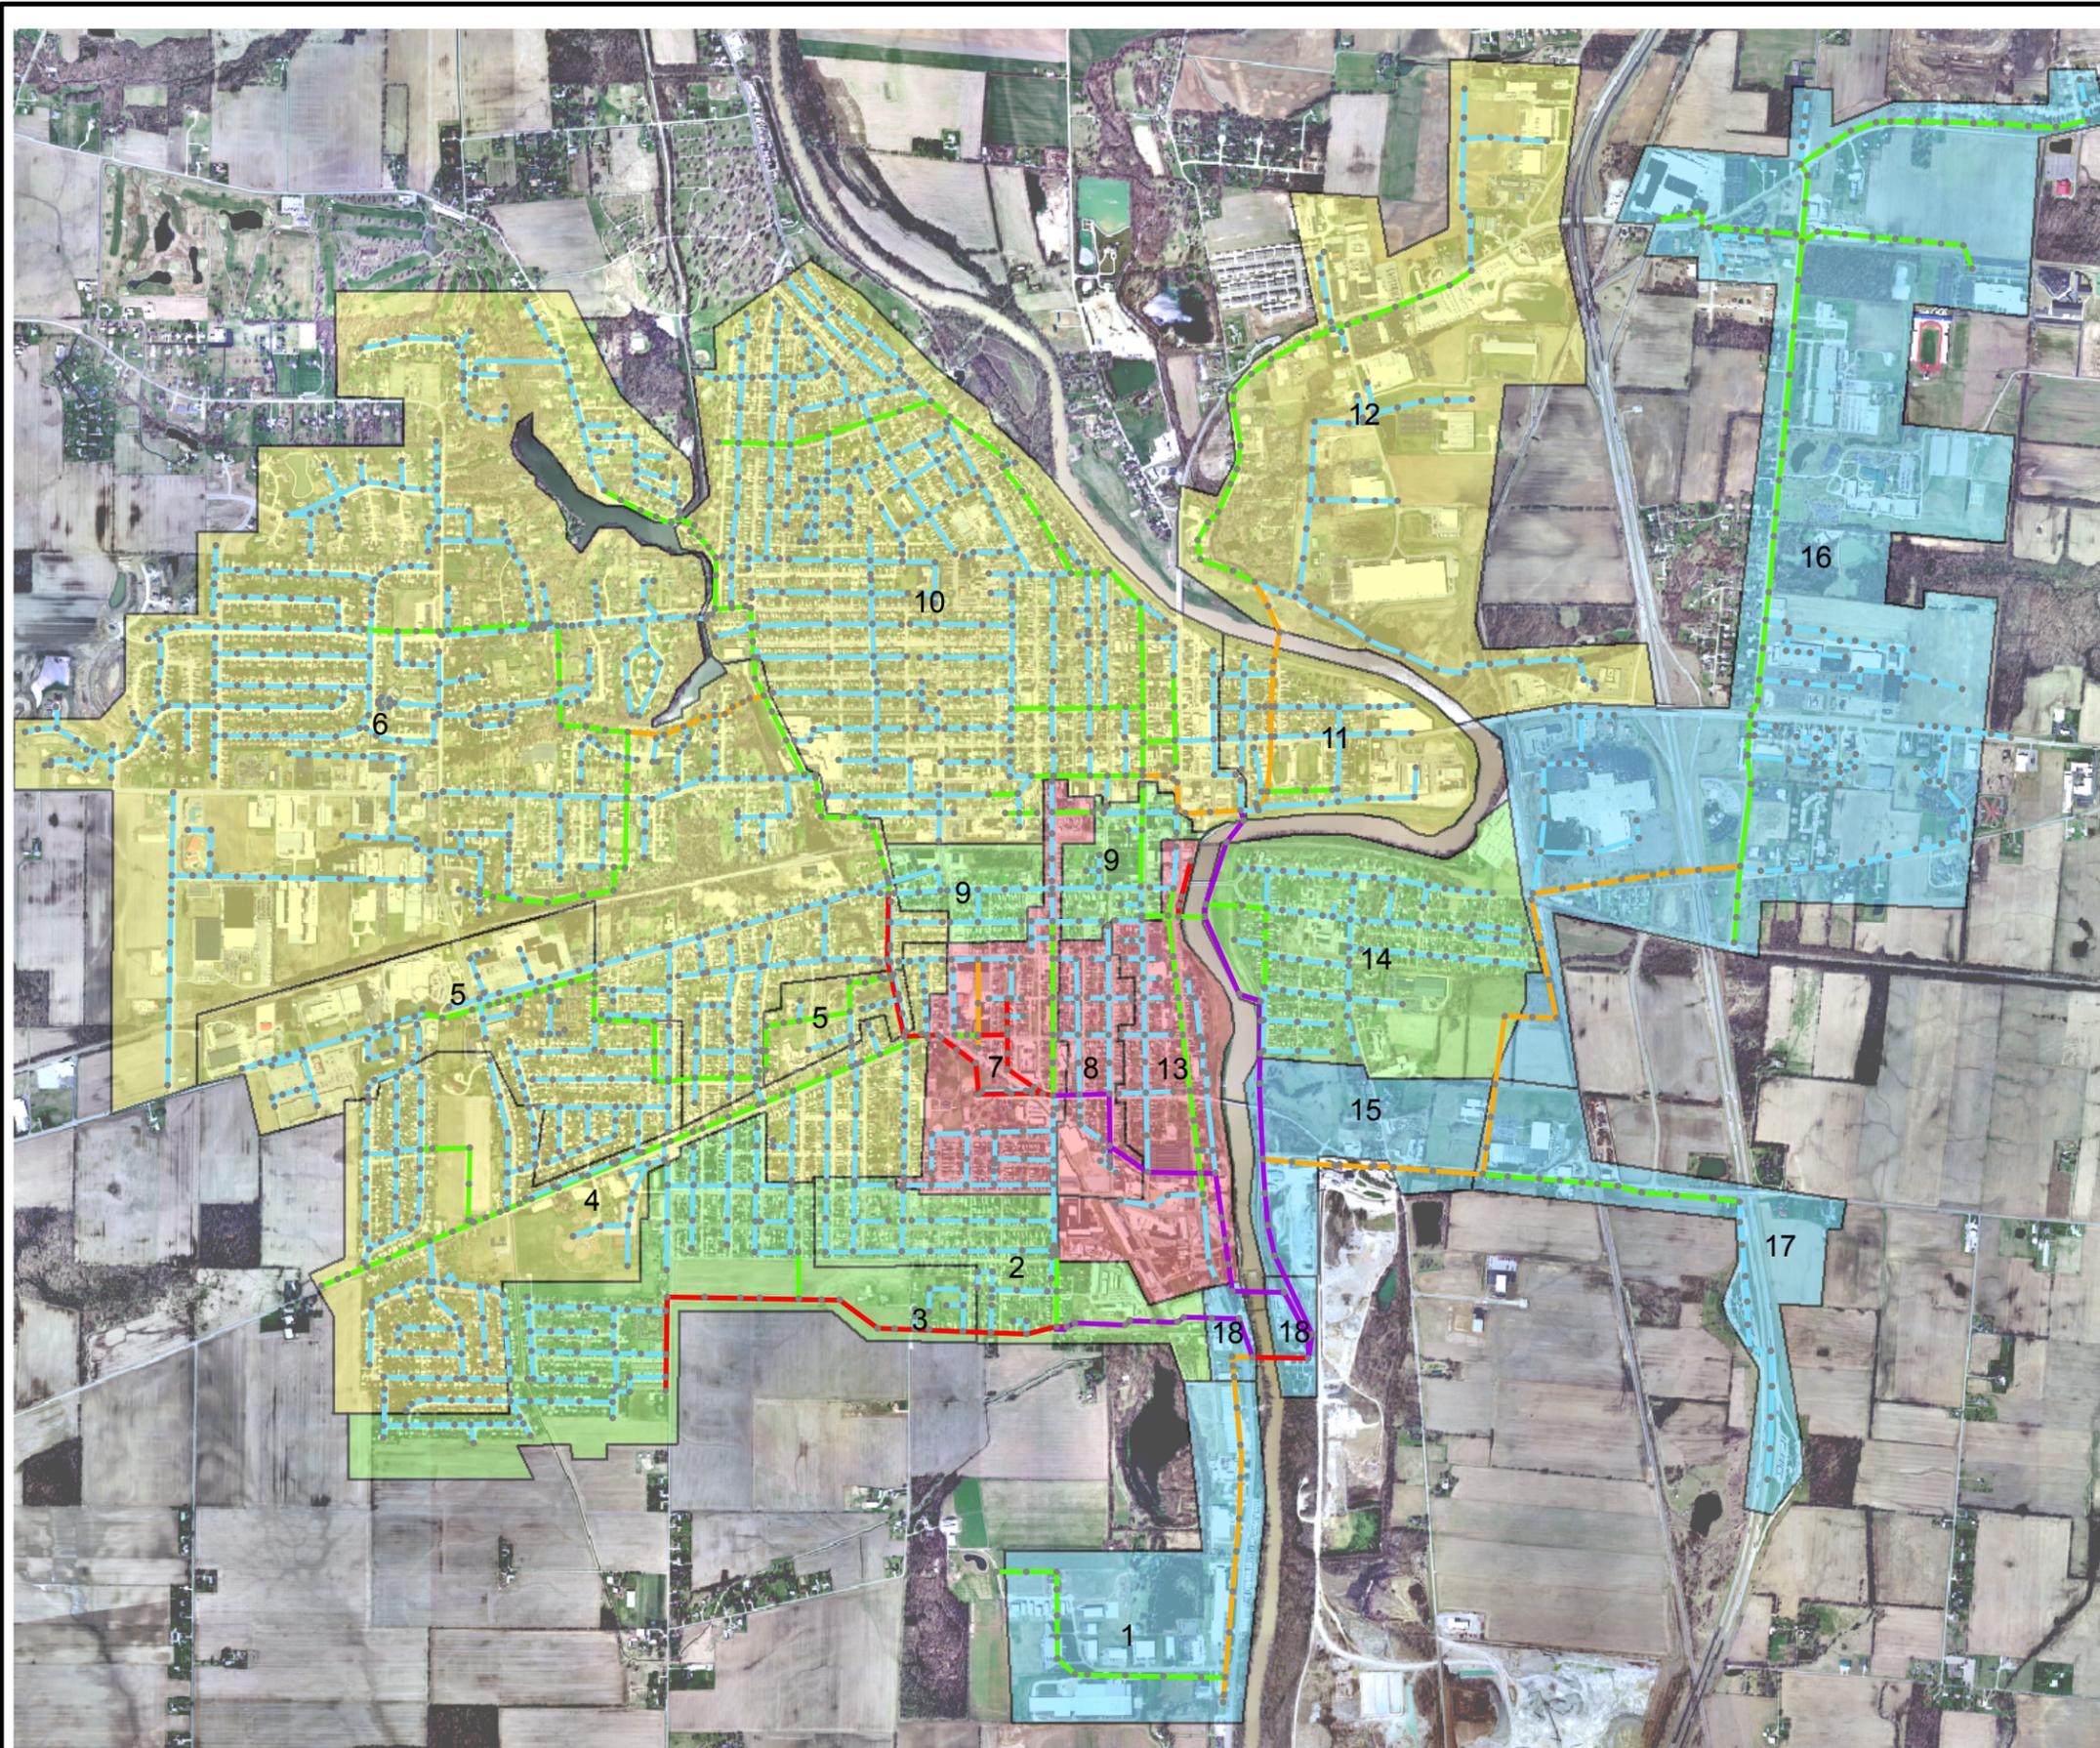
### Potential Inflow/Infiltration Problem Areas

Figure 1-1 shows these areas shaded in red and yellow. The red area is the Power Plant meter basin and a portion of the Garnsey Street meter basin. The Power Plant meter basin was identified as high RDI/I locations from the previous flow meter data and model analysis. A portion of the Garnsey Street meter basin was included in the red area due to observations by City employees over the past few years.

The yellow areas represent two basins, the Water Street meter basin and the Garnsey Street meter basin. These areas experienced peaking factors greater than five but capture ratios less than nine percent during rainfall events. These values indicate that high amounts of RDI/I are entering the collection system and that this RDI/I could potentially be reduced with cost effective methods, such as sewer rehabilitation or replacement, illicit connection removal, and

storm to sanitary sewer cross-connection elimination. The blue and green areas were identified as portions of the collection system that are not likely to have RDI/I that can be reduced with cost effective methods, or have very little RDI/I. A more detailed presentation of the methods used to collect the 2004 data, and the results of the data analysis, can be found in the “Sanitary Sewer Overflow Evaluation” report prepared by Malcolm Pirnie, Inc. in August 2006.

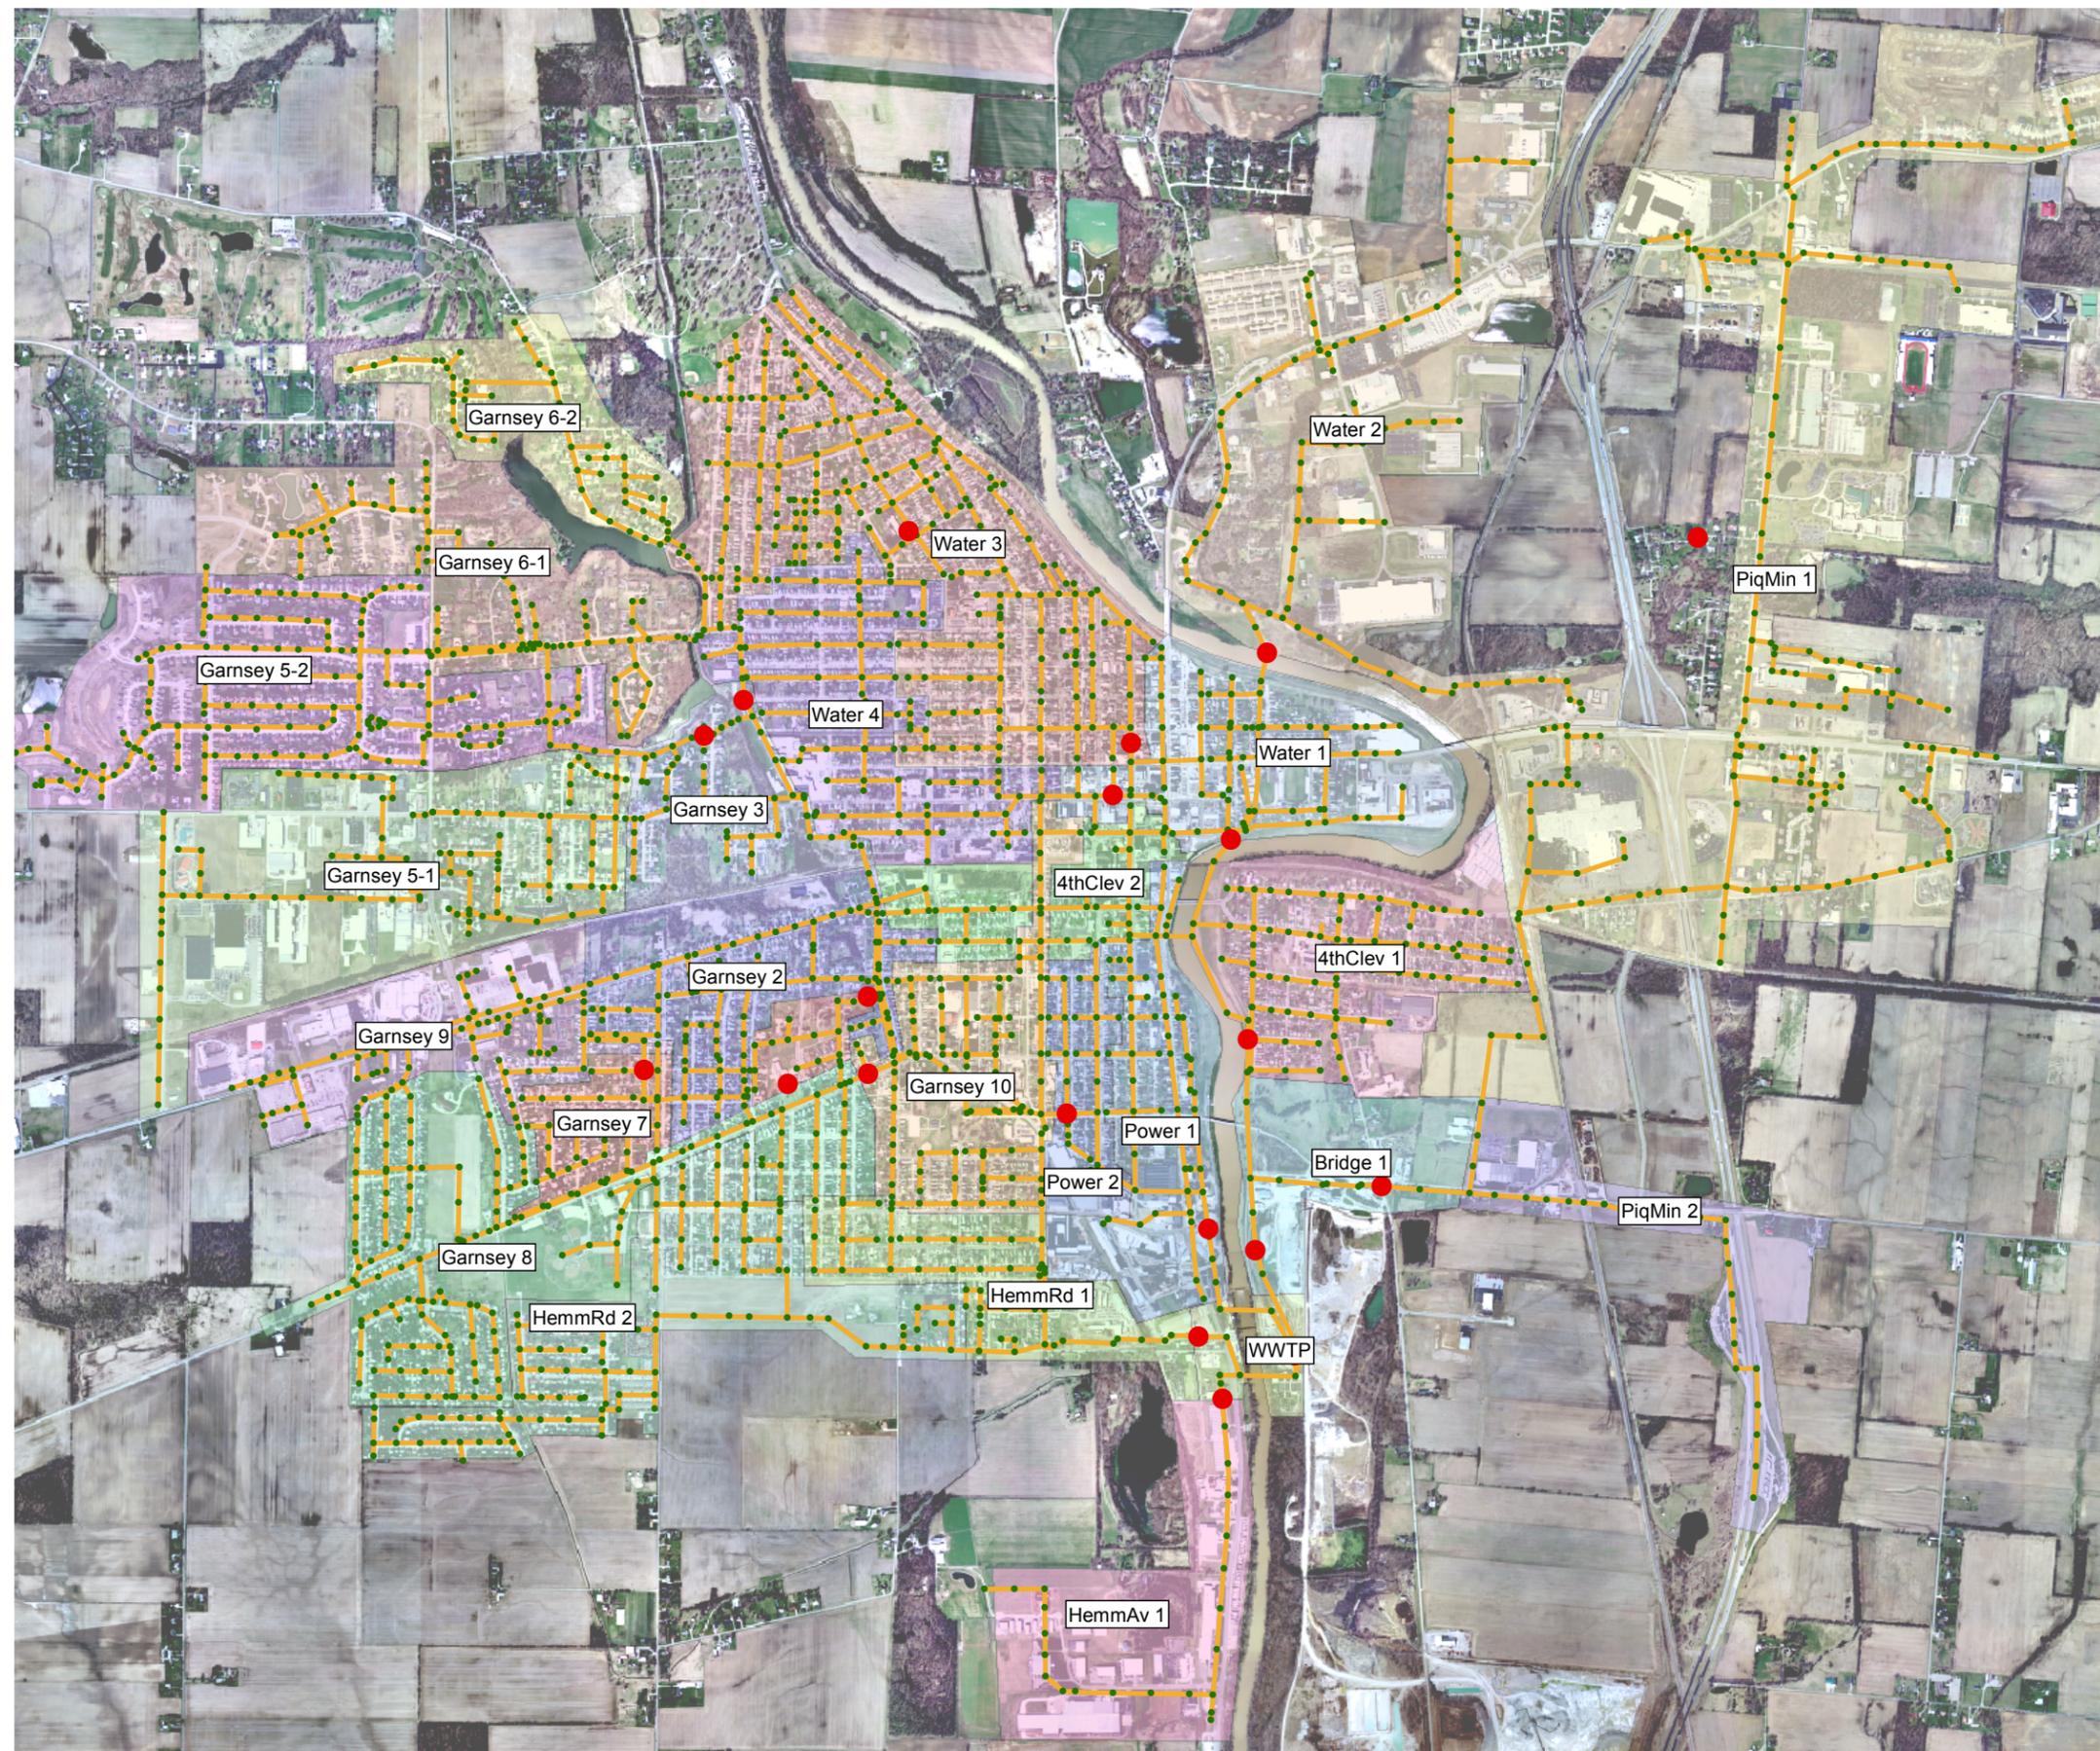
**SEWERSHED SUB-BASINS**  
 INFLOW AND INFILTRATION INVESTIGATION AND  
 SEWER SYSTEM EVALUATION SURVEY PLAN  
 CITY OF PIQUA, OHIO **FIGURE 2-1**

The Water Street drainage area was further divided into four sub-drainage areas, represented by flow monitors: FM01, FM02, FM03, and FM04. The Garnsey Street drainage area was divided into six sub-drainage areas: FM05, FM06, FM07, FM08, FM09, and FM10.

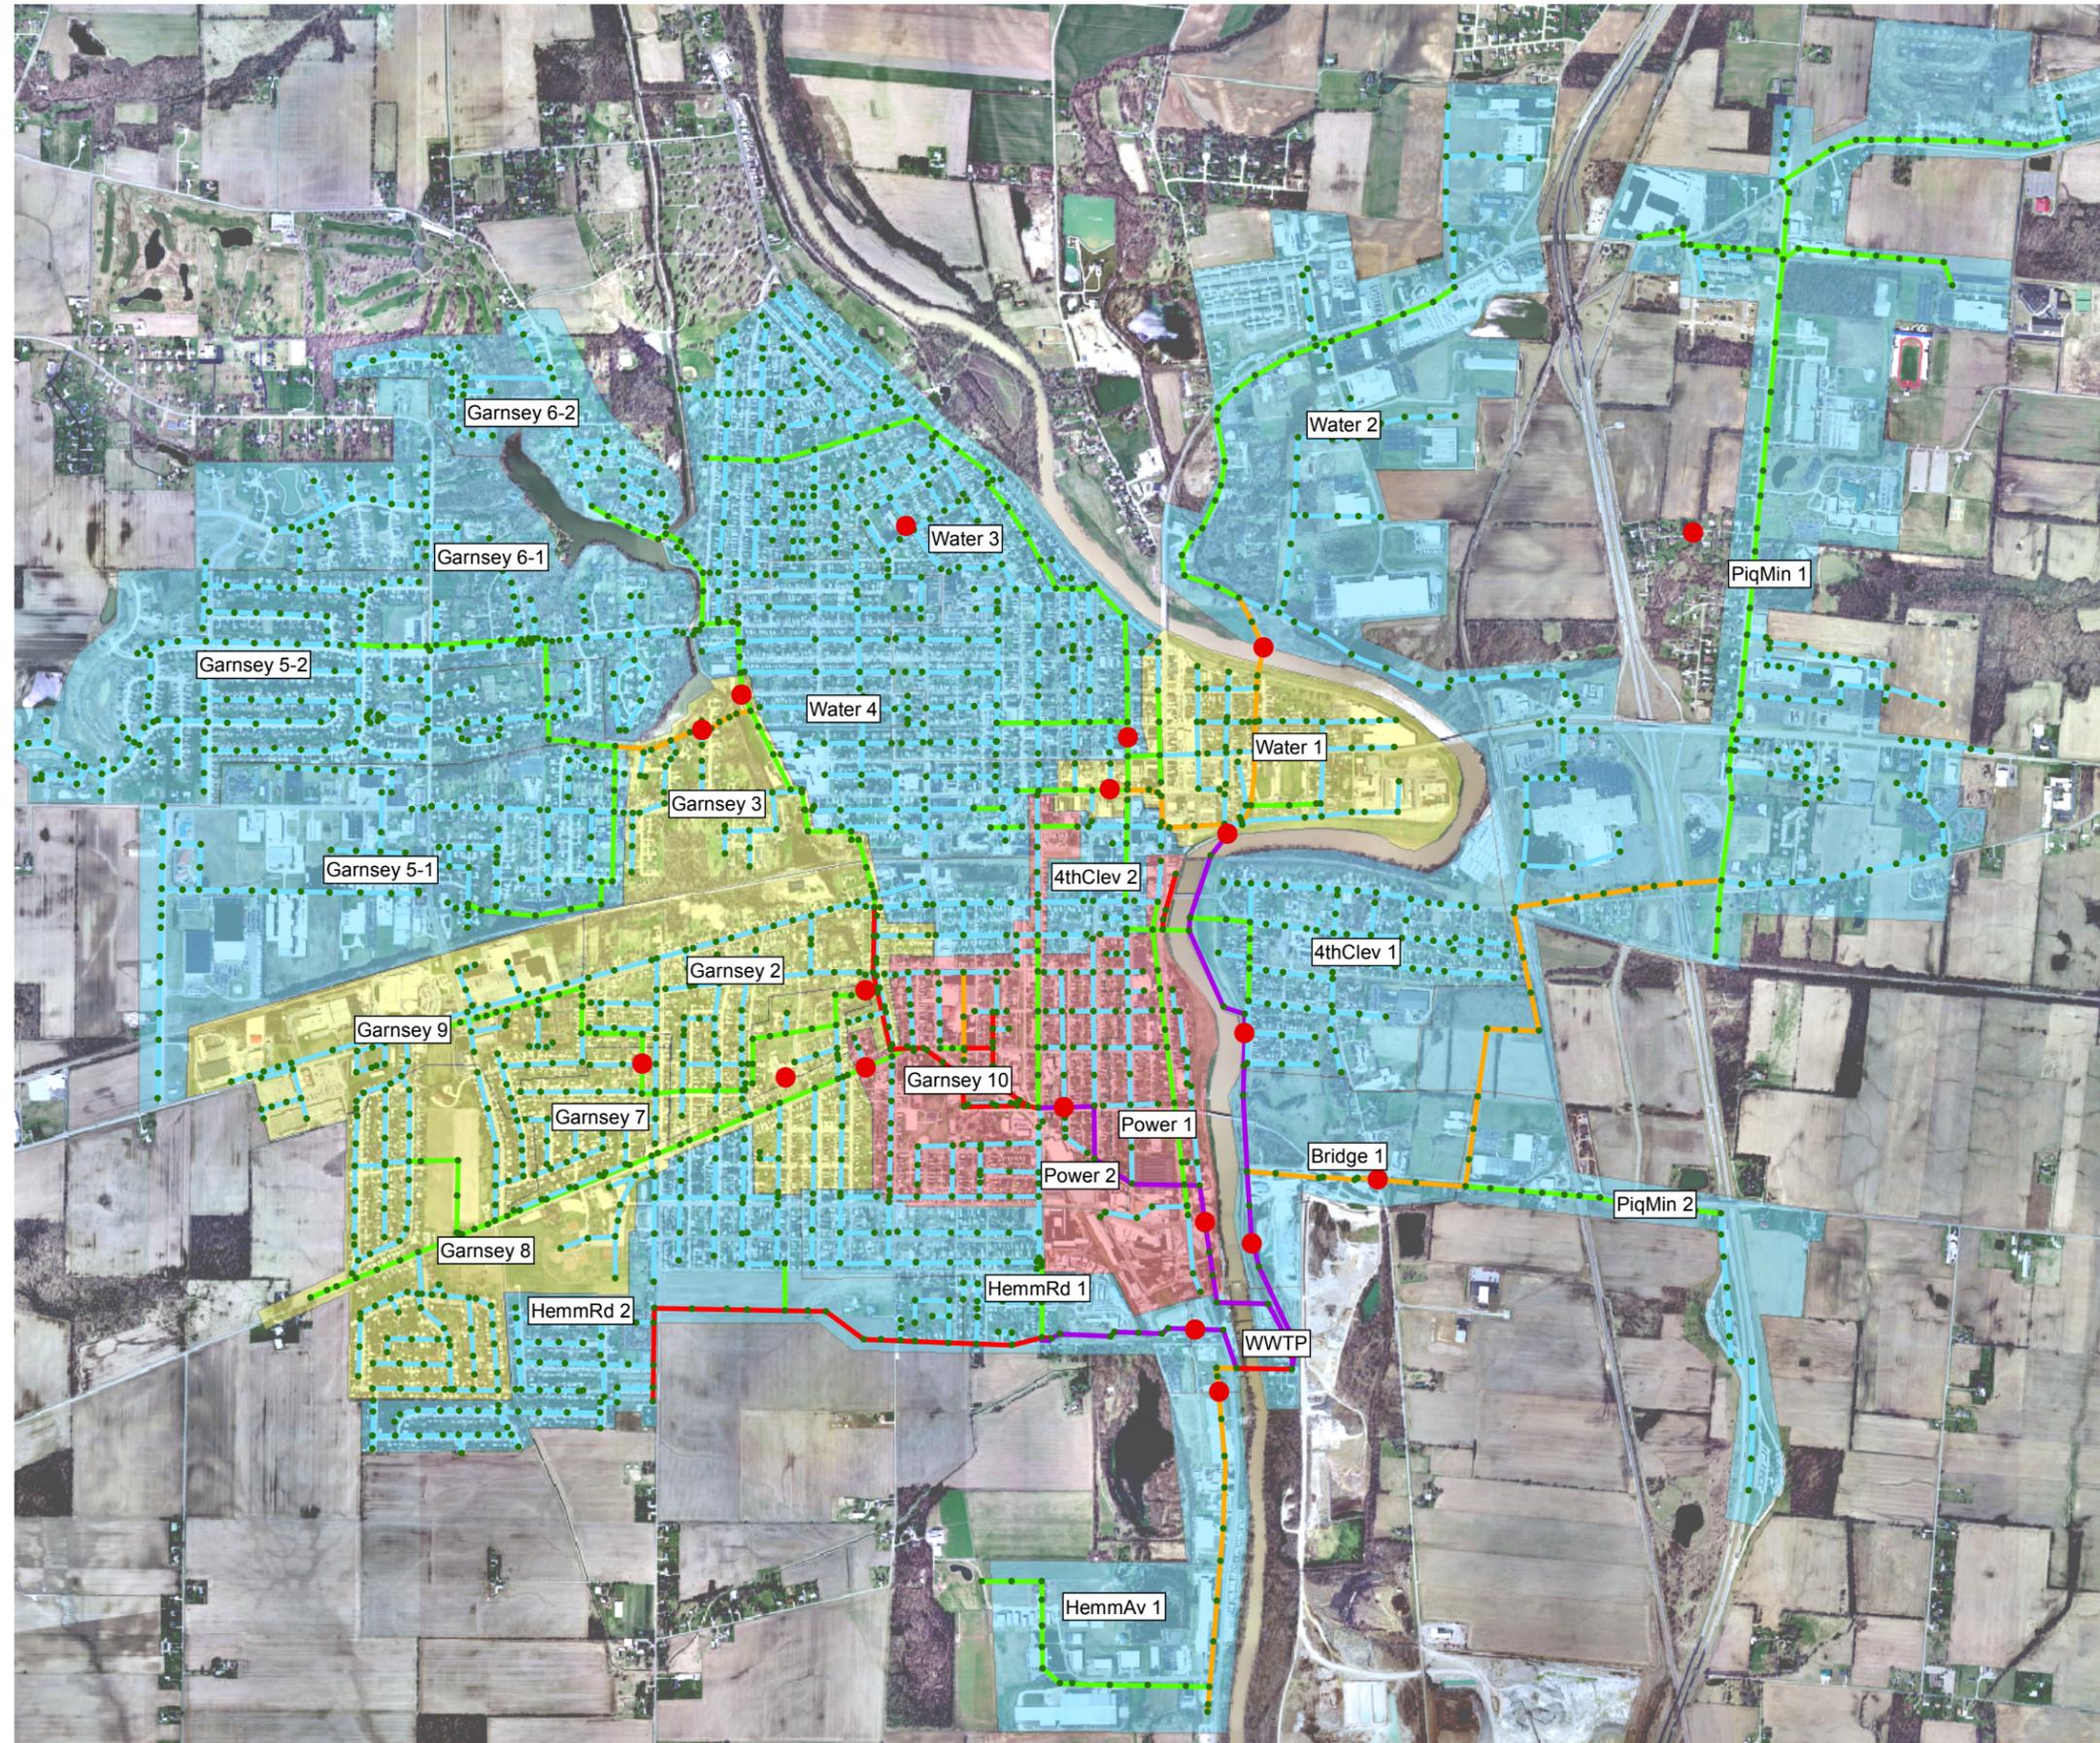
**Recommended SSES Program**

Phase I of the proposed SSES is the red area of Figure 3-1. This area was identified as having high RDI/I during the flow monitoring and model development that occurred between 2004 and 2006 as well as by field observations by City employees. Table 3-1 summarizes the infrastructure to be inspected during Phase I. The bottom portion of Figure 1-2 shows a proposed schedule for Phase I.

The SSES program has been separated into Phase I and Phase II. Phase I should begin in mid-September of 2006. This is to comply with the NPDES permit which was filed by the OEPA on August 1, 2006 and to allow the first step of the program, smoke testing, to be conducted during dry weather and low water table conditions. This will allow for the satisfaction of Part I, C – Schedule of Compliance, I. Municipal SSO Schedule, b.: Event Code 21599 – “The permittee shall begin phase one of a Sanitary Sewer Evaluation Survey as soon as possible, but not later than 2 months from the effective date of the permit.” A four month duration for Phase I will satisfy Part I, C – Schedule of Compliance, I. Municipal SSO Schedule, c.: Event Code 21599 – “The permittee shall complete and submit a copy of the phase one Sanitary Sewer Evaluation Survey as soon as possible, but not later than 6 months from the effective date of the permit to the Ohio EPA Southwest District Office.” Phase II should begin in June 2007 to comply with the filed NPDES permit.

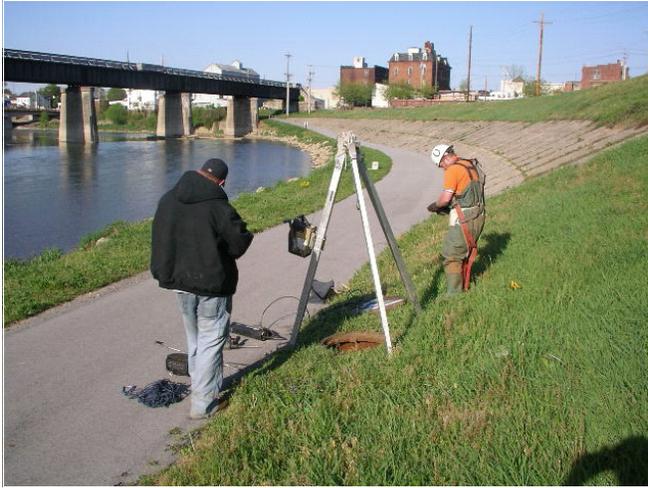
FM01 Area Photo

Site Hazards	Meter Setup	Site Conditions
Heavy Traffic? No H2S? No Sufficient O2? No LEL Ok? No Steps Ok? No	Measure Depth (in): 11 Portable Vel. (fps): 1.25 Cycle (minutes):	Surcharge Evidence? No Depth of Surcharge (ft): Depth of Silt (in): 4
Describe any potential hazards	<b>Real-time Readings</b> Level (in): 7 Velocity (fps): 1.19 Battery (volts): 6 Sensor Offset (in): 5 Meter Running? Yes	Comments: There is about 4" of silt in the bottom of this line.
MH needs tri-pod	Comments: Used a side mount offset band that should work for this site.

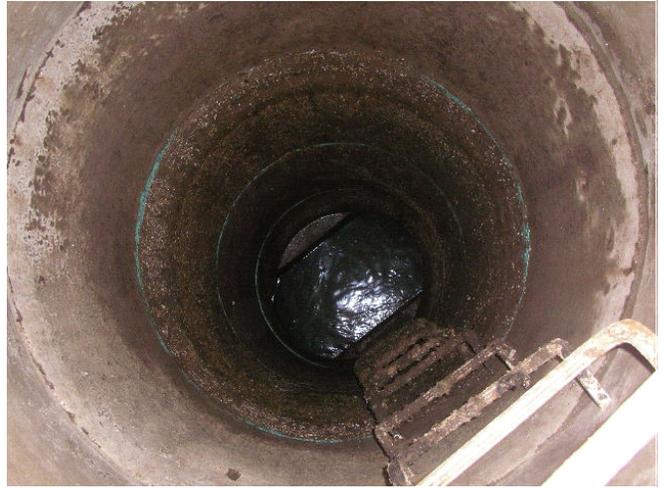
FM01 Manhole Photo

The scatter plot indicates that this site experienced normal open channel flow characteristics with backwater effects and surcharging during heavy rainfall events. The hydrograph shows a minor impact on the flow during rainfall events. The flows from sites 2, 3 and 4 are tributary to this location.

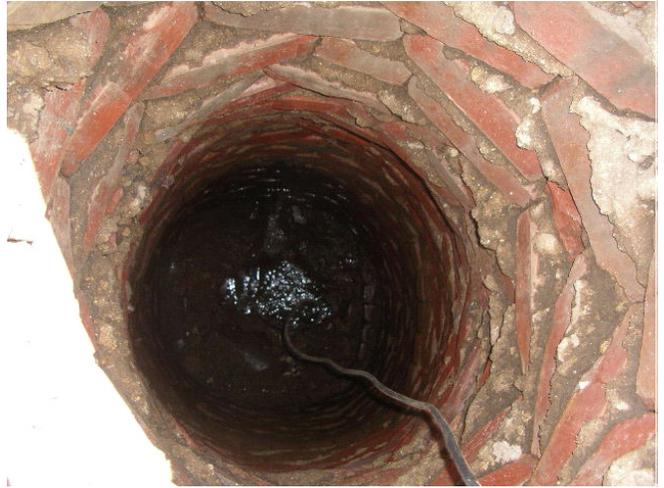
FM03 Manhole Photo

Site Hazards	Meter Setup	Site Conditions
Heavy Traffic? No H2S? No Sufficient O2? No LEL Ok? No Steps Ok? No	Measure Depth (in): 8 Portable Vel. (fps): 0.5 Cycle (minutes): 15	Surcharge Evidence? No Depth of Surcharge (ft): Depth of Silt (in):
Describe any potential hazards	<b>Real-time Readings</b> Level (in): 7.9 Velocity (fps): 0.59 Battery (volts): 6 Sensor Offset (in): Meter Running? Yes	Comments:
no rungs, needs tri-pod	Comments:

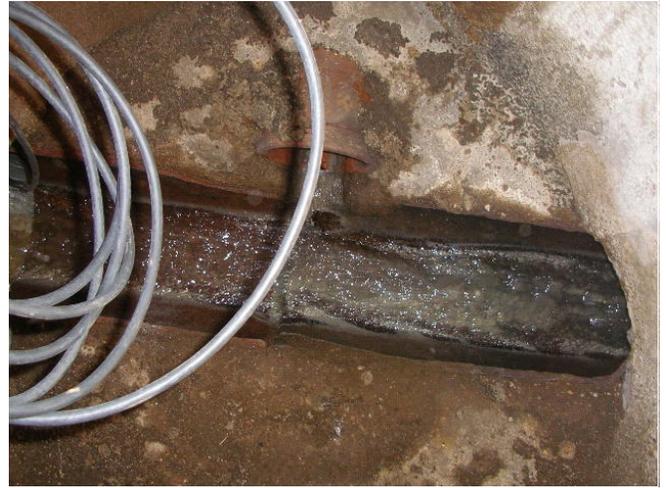
FM08 Manhole Photo

Site Hazards	Meter Setup	Site Conditions
Heavy Traffic? No H2S? No Sufficient O2? No LEL Ok? No Steps Ok? No	Measure Depth (in): 2 Portable Vel. (fps): 3.75 Cycle (minutes): 15	Surcharge Evidence? No Depth of Surcharge (ft): Depth of Silt (in):
Describe any potential hazards	<b>Real-time Readings</b> Level (in): 1.984 Velocity (fps): 3.88 Battery (volts): 6 Sensor Offset (in): Meter Running? Yes	Comments:
small hole	Comments: high velocity and low flow could cause some problems at night and in the summer but should be fine in the day time.

The meter was moved one manhole upstream on May 15, 2006 because of the high velocities and low levels causing difficult hydraulic conditions at the site.

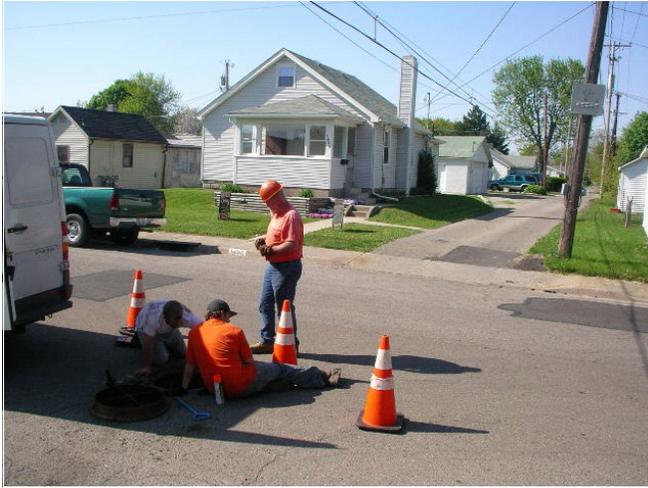
FM09 Area Photo

Site Hazards	Meter Setup	Site Conditions
Heavy Traffic? No H2S? No Sufficient O2? No LEL Ok? No Steps Ok? No	Measure Depth (in): 3 Portable Vel. (fps): 1.65 Cycle (minutes): 15	Surcharge Evidence? No Depth of Surcharge (ft): Depth of Silt (in):
Describe any potential hazards	<b>Real-time Readings</b> Level (in): 2.991 Velocity (fps): 1.77 Battery (volts): 6 Sensor Offset (in): Meter Running? Yes	Comments:
rungs bad and rusty	Comments:
