SITE ASSESSMENT WORK PLAN

FORMER WATER TREATMENT PLANT
9300 OH-66
PIQUA, OHIO
WSP PROJECT #7775232021

DECEMBER 21, 2023

PREPARED FOR:
CITY OF PIQUA
121 BRIDGE STREET,
PIQUA, OH 45356

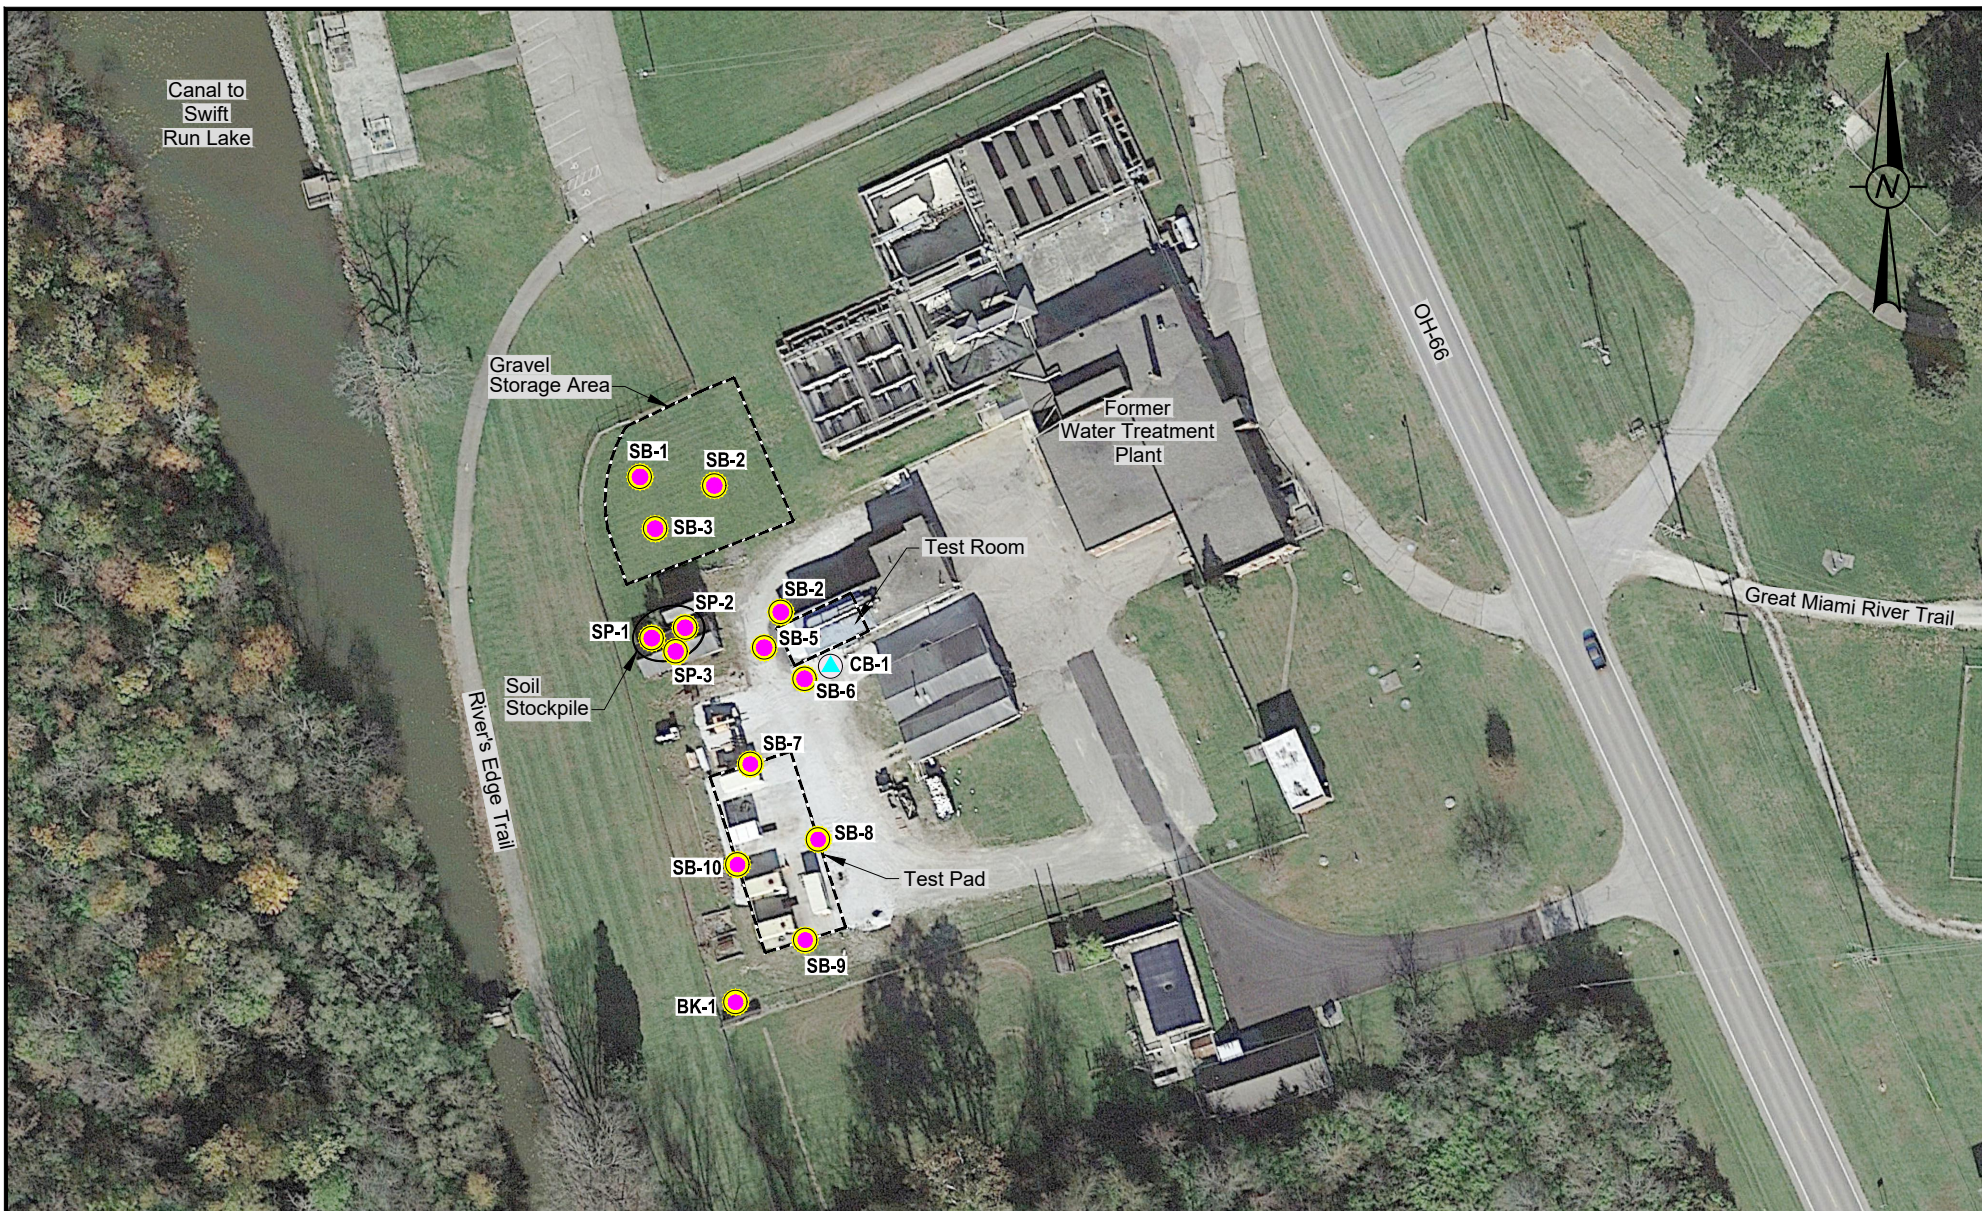
- Proposed Soil Sampling Location
- Proposed Storm Water Sampling Location

Three soil borings will be conducted through the gravel surrounding the Test Room, as shown on **Figure 2**. The borings will be advanced to 4-feet (ft) below ground surface (bgs), and soil samples will be collected from the following depth intervals for laboratory analyses:

Four soil borings will be conducted just beyond the pavement in the area of the Test Pad as shown on **Figure 2**. The borings will be advanced to 4-ft bgs, and soil samples will be collected from the following depth intervals for laboratory analyses:

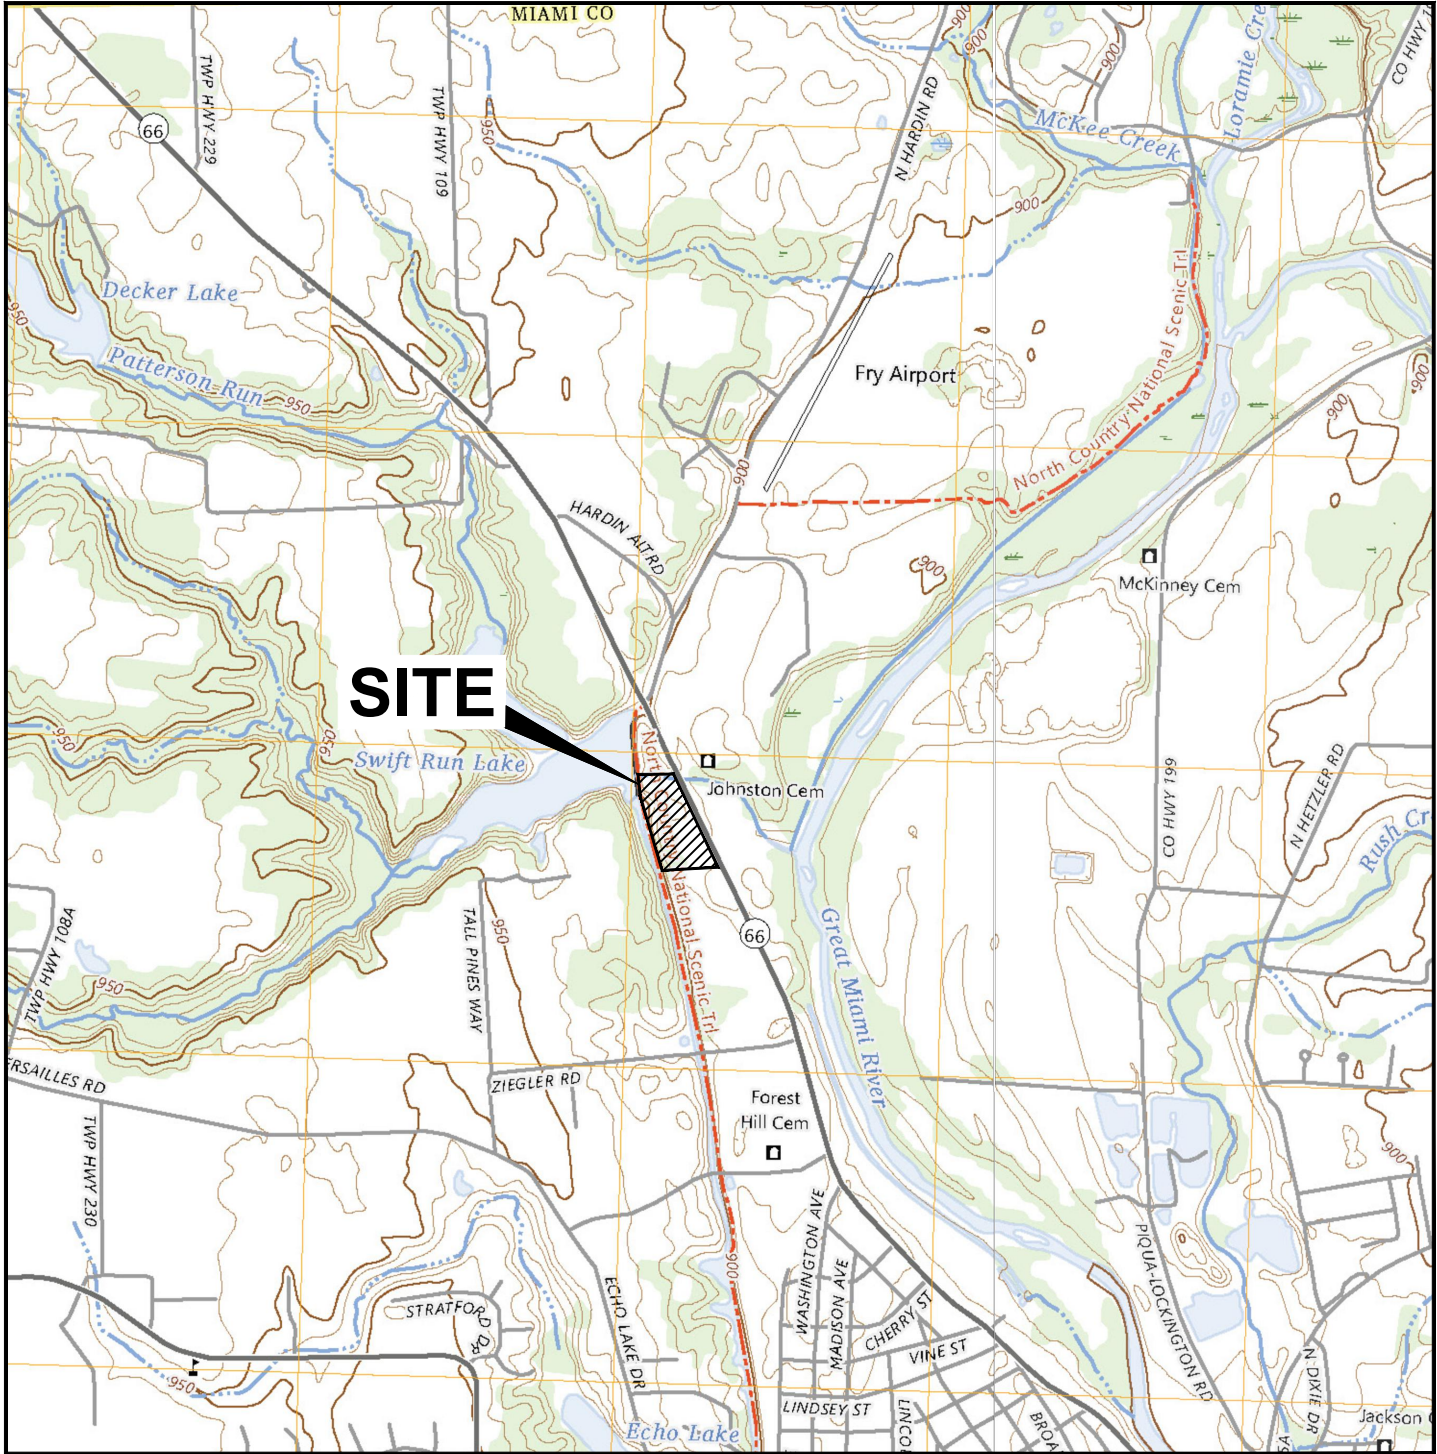
PROJECT NO. 7775 23 2021
 REV. FIGURE 1

TITLE
SITE LOCATION MAP

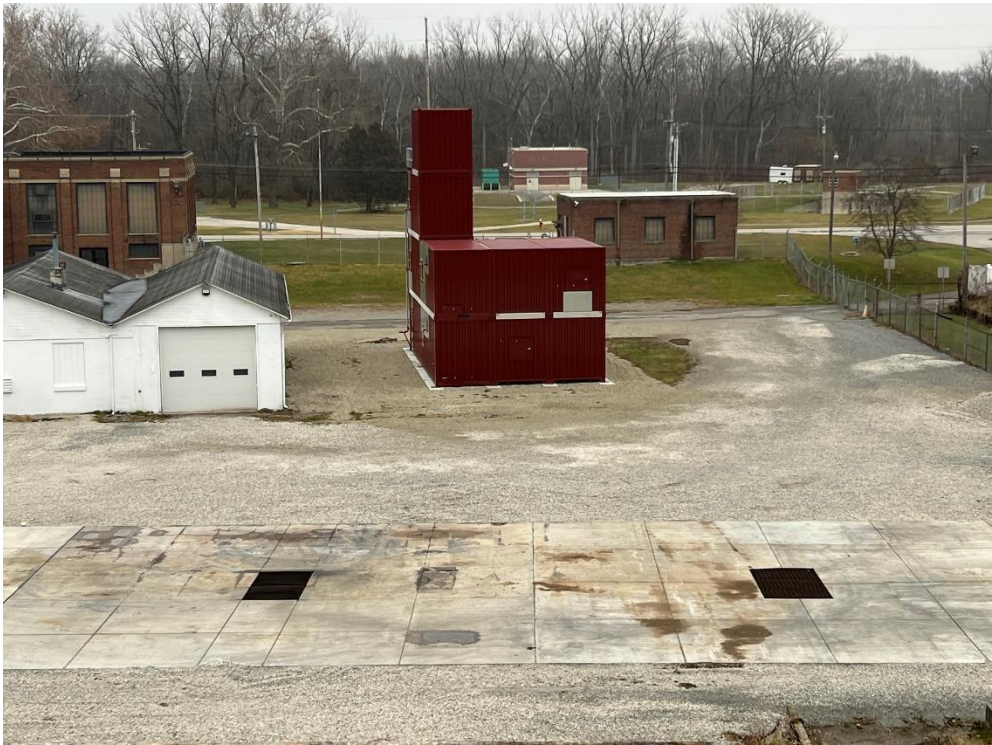
Site Assessment Work Plan	9300 OH-66	Piqua, Ohio
Photograph No. 3

Date: 12/3/2023		
Description:		
View of Test Pad (foreground) with two basins. New fire training building (red) in center of photograph.		
Orientation:		
Facing East

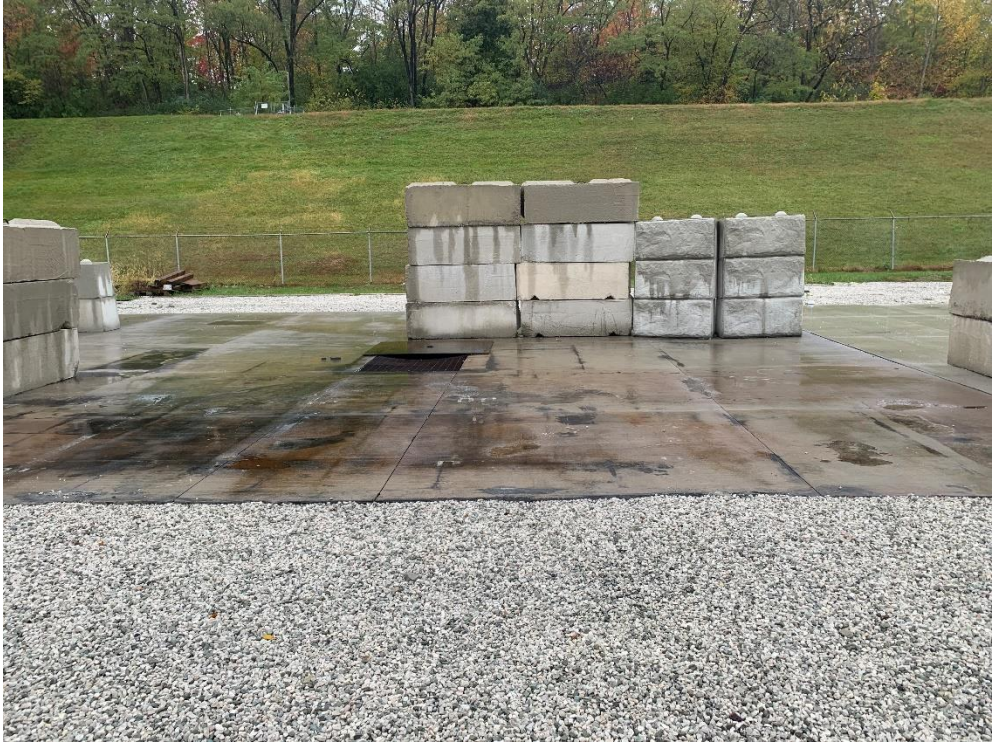
Photograph No. 4

Date: 12/3/2023		
Description:		
Test pad and basin.		
Orientation:		
Facing West.

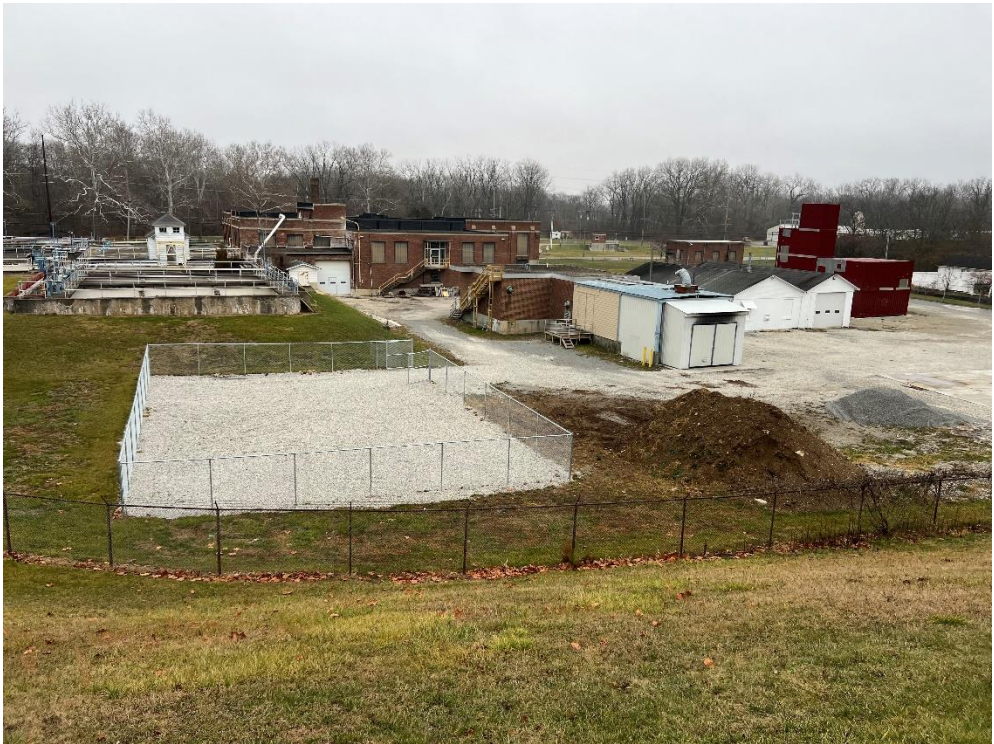
Site Assessment Work Plan	9300 OH-66	Piqua, Ohio
Photograph No. 5

Date: 12/3/2023		
Description:		
Fenced gravel covered storage area and soil stockpile (foreground)		
Orientation:		
Facing East

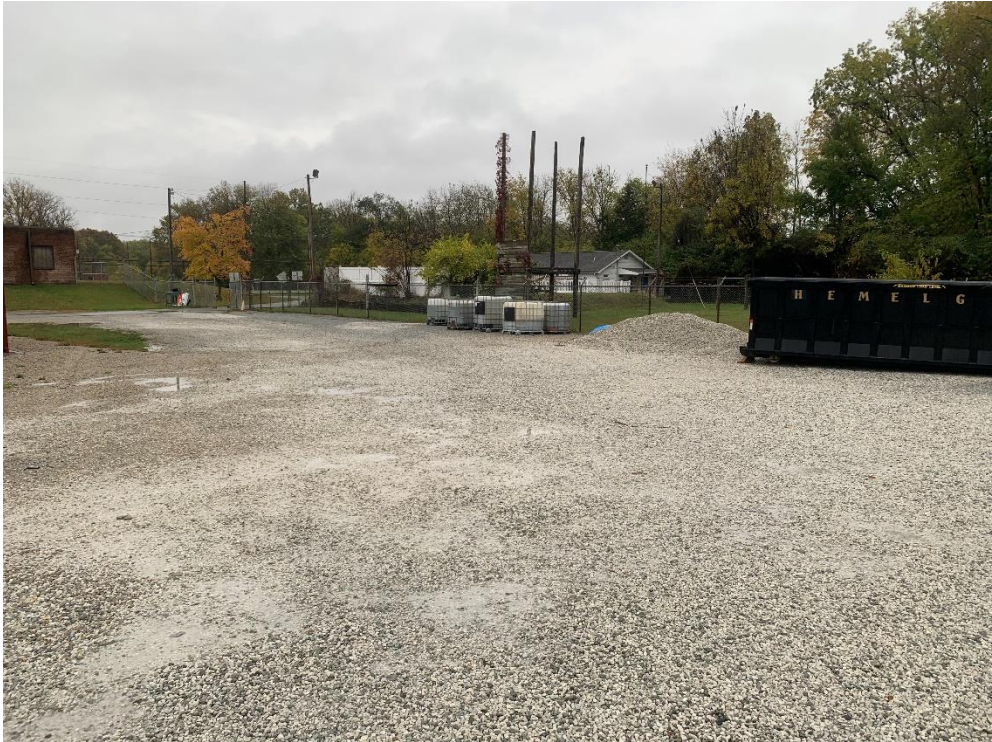
Site Assessment Work Plan	9300 OH-66	Piqua, Ohio
Photograph No. 7

Date: 10/20/2023		
Description:		
Storage of wastewater totes pending pickup for off-site processing.		
Orientation:		
Facing East
