# CITY OF PIQUA, OHIO

## INFLOW AND INFILTRATION INVESTIGATION AND SEWER SYSTEM EVALUATION SURVEY PLAN

FINAL REPORT

OCTOBER 2006

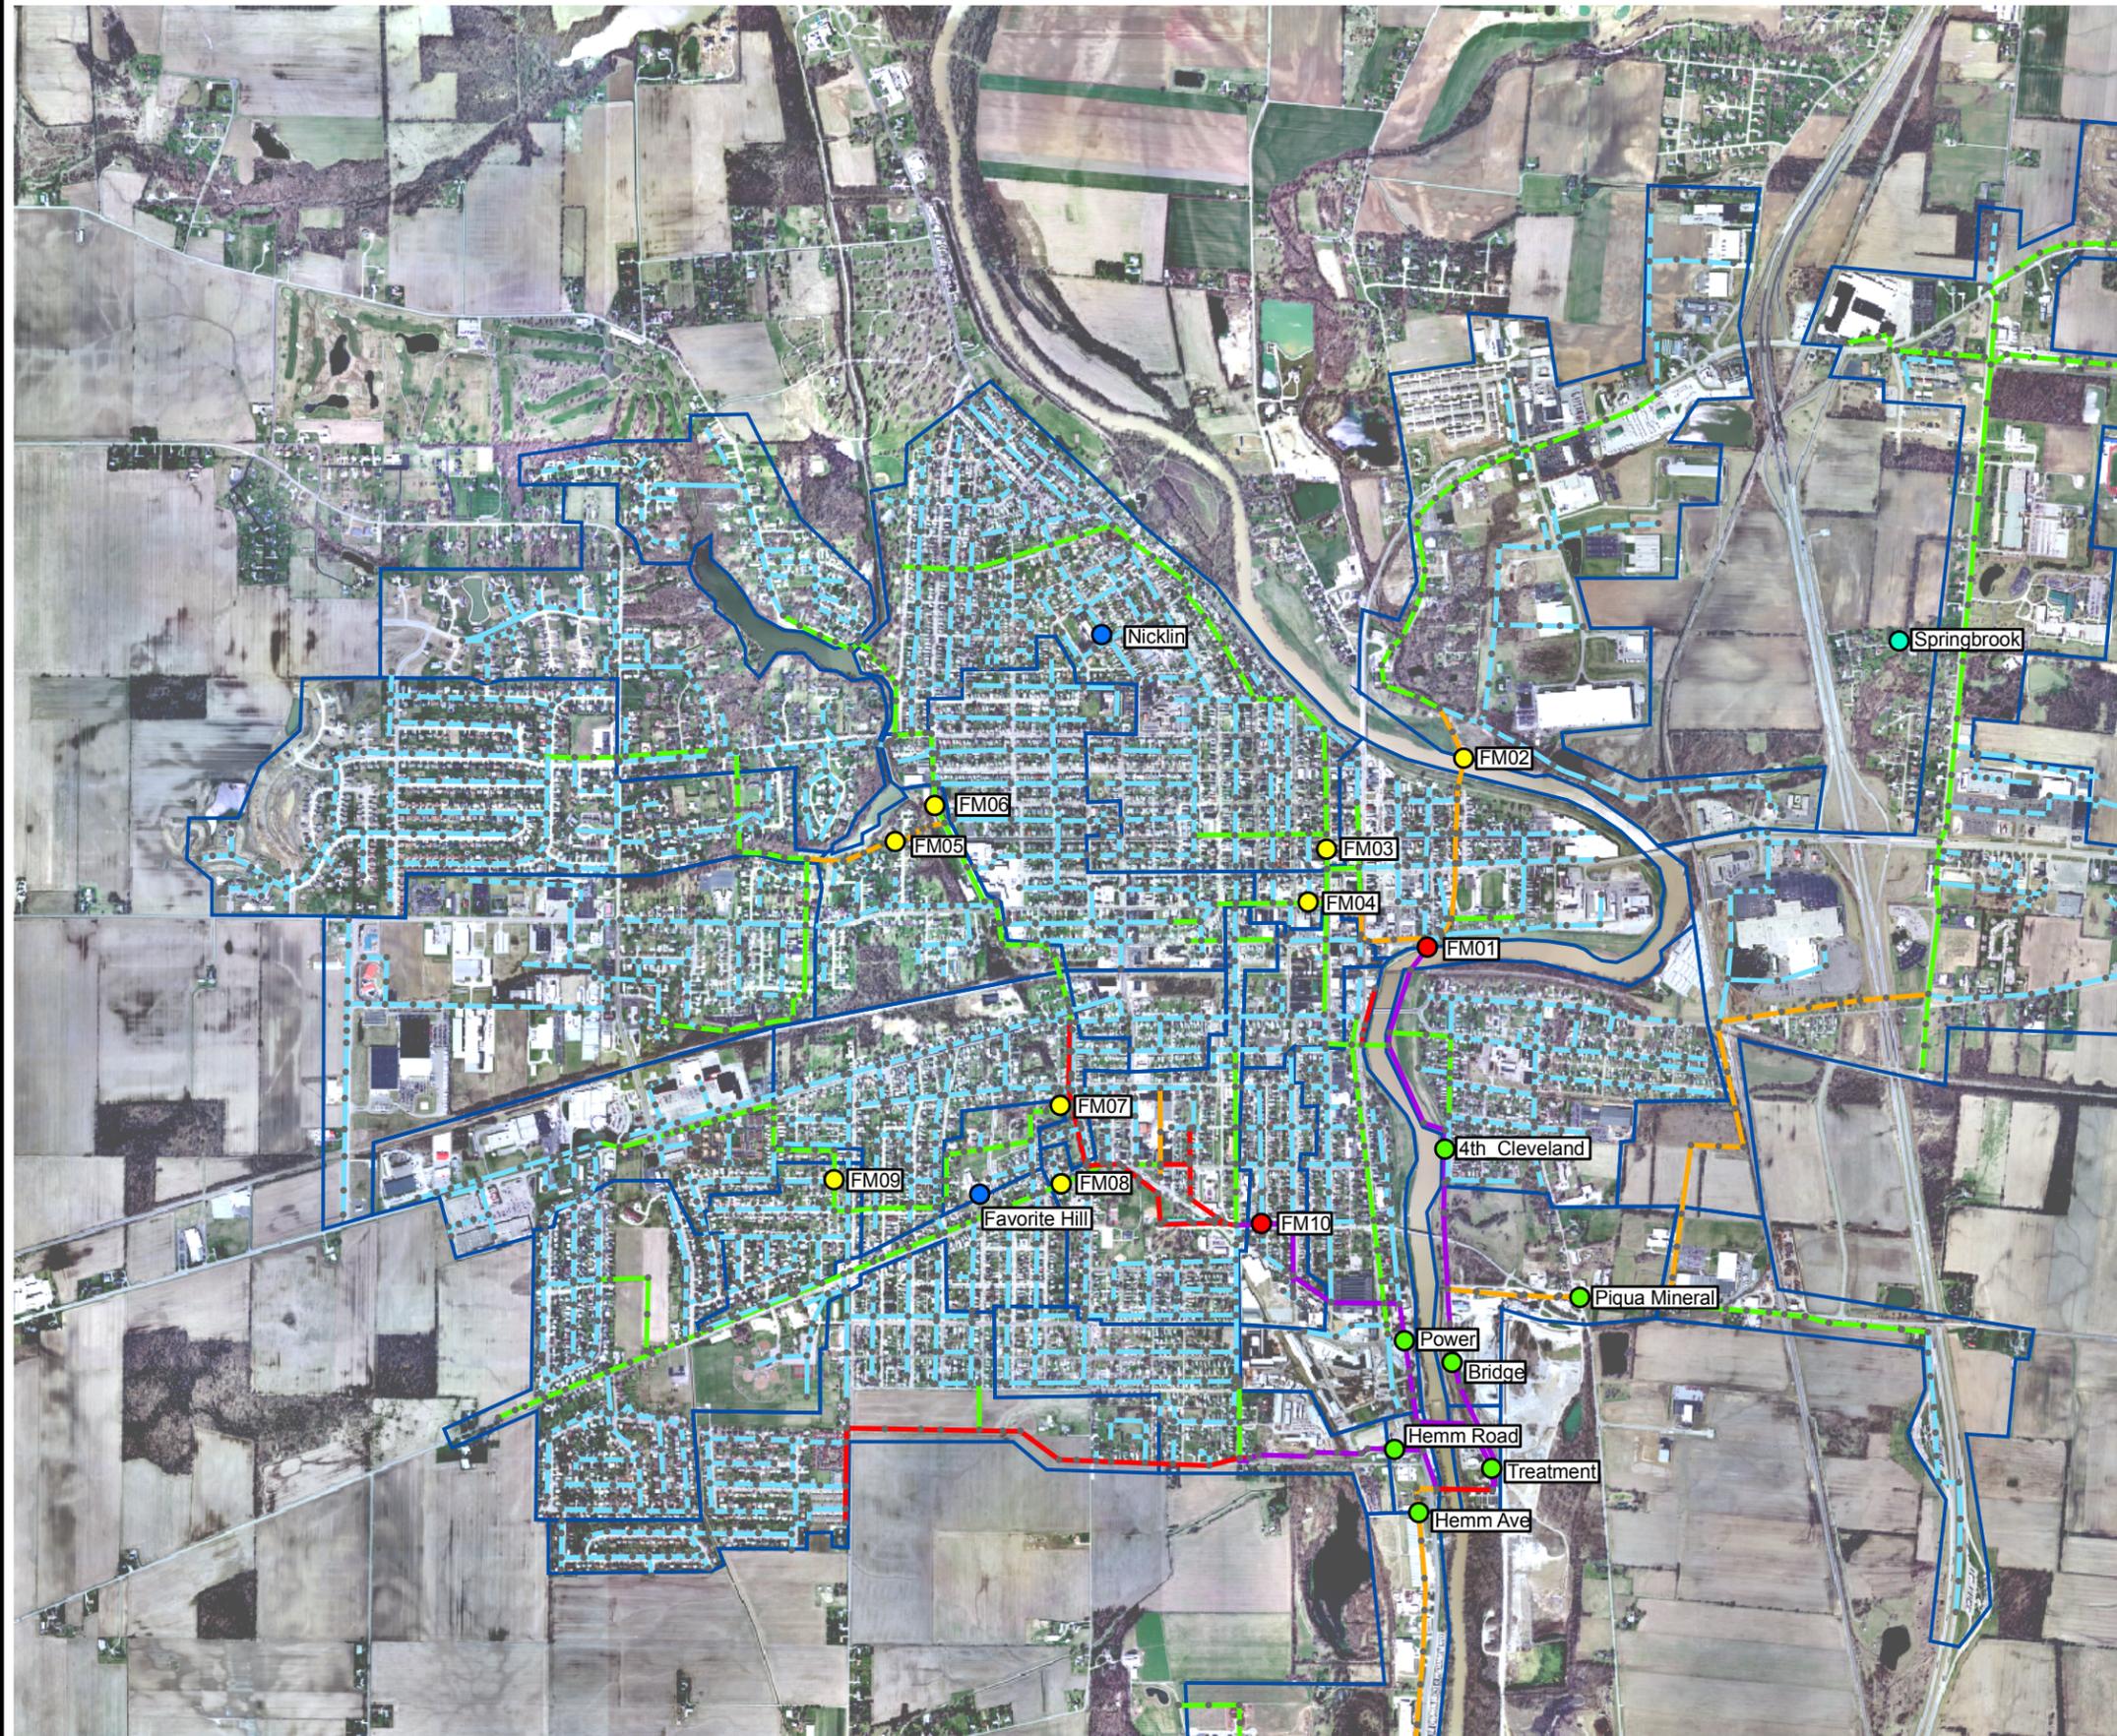
**SEWERSHED SUB-BASINS**  
 INFLOW AND INFILTRATION INVESTIGATION AND  
 SEWER SYSTEM EVALUATION SURVEY PLAN  
 CITY OF PIQUA, OHIO **FIGURE 2-1**

Data collected during previous studies identified two areas (yellow) requiring additional flow monitoring and one area (red) that has significant amounts of RDI/I during spring conditions and/or large rainfall events. These areas are shown in Figure 1-1. The basins were divided into sub-basins as shown in Figure 2-1.

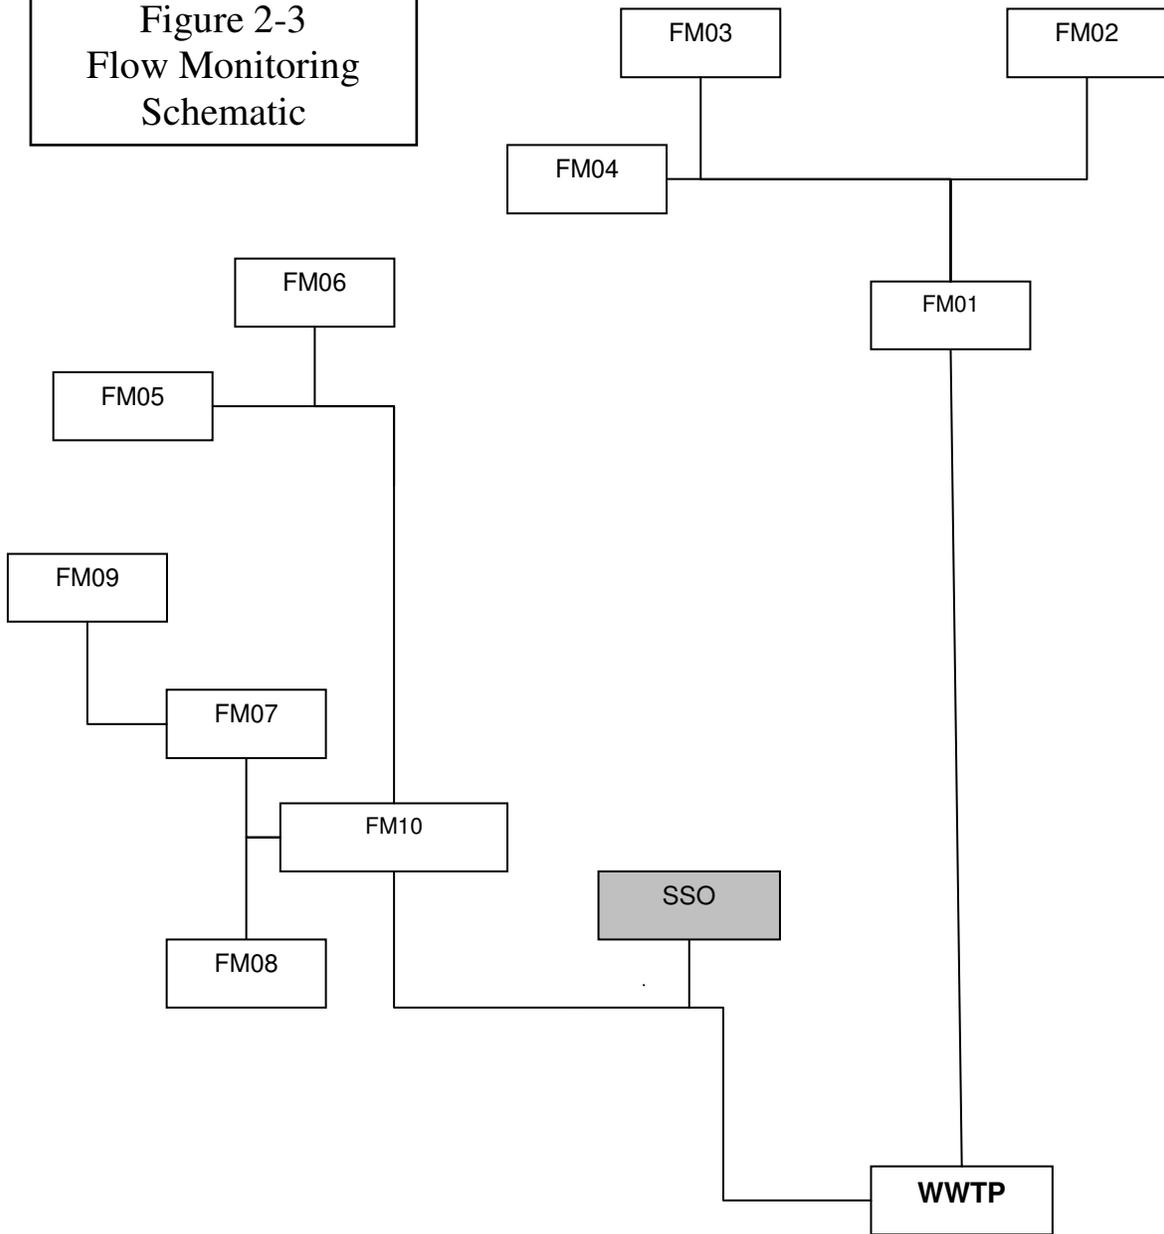
Figure 2-3  
Flow Monitoring  
Schematic

The yellow area can be further divided into the drainage area tributary to the Water Street meter and the drainage area tributary to the Garnsey Street meter. Figure 2-2 shows these meters, as well as the locations of all the meters used in the 2004 study, as well as the additional meters used in this project. Figure 2-3 shows a flow schematic of the collection system in relation to the flow meters.

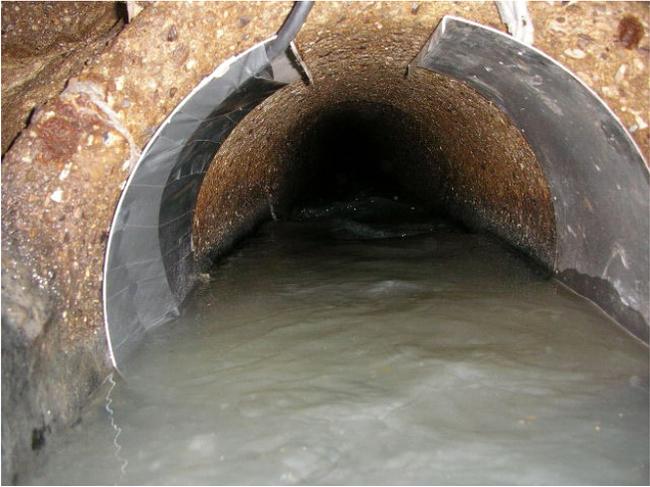
FM05 Pipe Photo

Site Hazards	Meter Setup	Site Conditions
Heavy Traffic? No H2S? No Sufficient O2? No LEL Ok? No Steps Ok? No	Measure Depth (in): 6 Portable Vel. (fps): 1.6 Cycle (minutes): 15	Surcharge Evidence? No Depth of Surcharge (ft): Depth of Silt (in):
Describe any potential hazards	<b>Real-time Readings</b> Level (in): 6.15 Velocity (fps): 1.7 Battery (volts): 6 Sensor Offset (in): Meter Running? Yes	Comments: sensor is in the down stream line but is facing upstream. There will be no hydraulic problems here.
no rungs tri-pod is a must	Comments: It was a badly shaped concrete line.

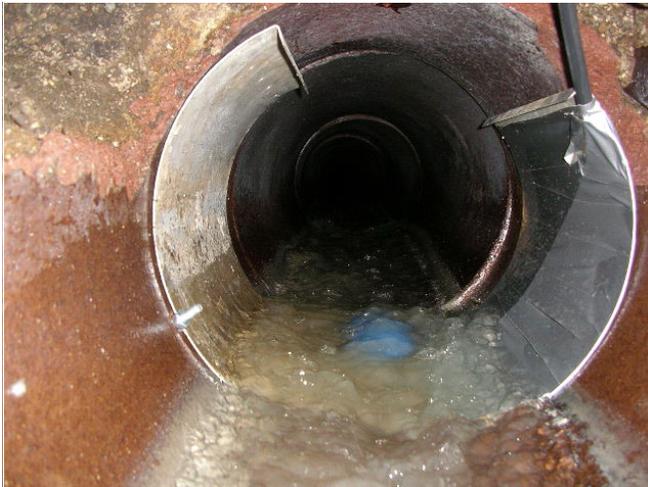
FM08 Pipe Photo

Site Hazards	Meter Setup	Site Conditions
Heavy Traffic? No H2S? No Sufficient O2? No LEL Ok? No Steps Ok? No	Measure Depth (in): 2 Portable Vel. (fps): 3.75 Cycle (minutes): 15	Surcharge Evidence? No Depth of Surcharge (ft): Depth of Silt (in):
Describe any potential hazards	<b>Real-time Readings</b> Level (in): 1.984 Velocity (fps): 3.88 Battery (volts): 6 Sensor Offset (in): Meter Running? Yes	Comments:
small hole	Comments: high velocity and low flow could cause some problems at night and in the summer but should be fine in the day time.

The meter was moved one manhole upstream on May 15, 2006 because of the high velocities and low levels causing difficult hydraulic conditions at the site.

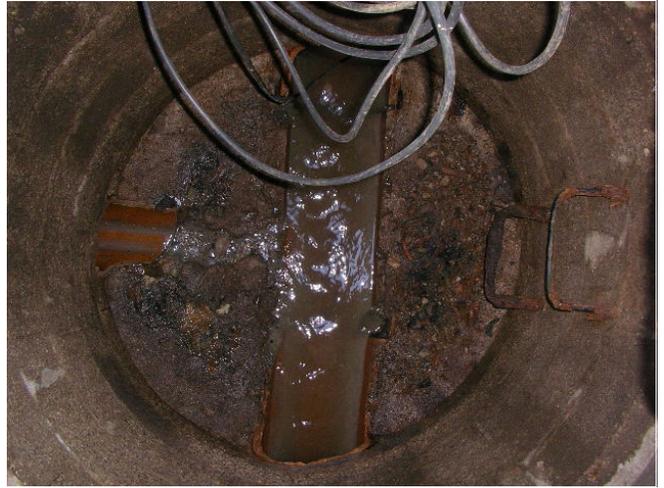
FM09 Manhole Photo

Site Hazards	Meter Setup	Site Conditions
Heavy Traffic? No H2S? No Sufficient O2? No LEL Ok? No Steps Ok? No	Measure Depth (in): 3 Portable Vel. (fps): 1.65 Cycle (minutes): 15	Surcharge Evidence? No Depth of Surcharge (ft): Depth of Silt (in):
Describe any potential hazards	<b>Real-time Readings</b> Level (in): 2.991 Velocity (fps): 1.77 Battery (volts): 6 Sensor Offset (in): Meter Running? Yes	Comments:
rungs bad and rusty	Comments:

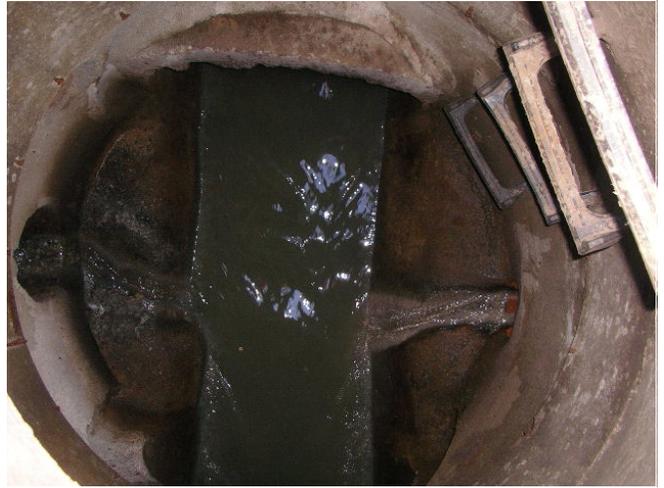
FM10 Manhole Photo

Site Hazards	Meter Setup	Site Conditions
Heavy Traffic? No H2S? No Sufficient O2? No LEL Ok? No Steps Ok? No	Measure Depth (in): 6.5 Portable Vel. (fps): 2.55 Cycle (minutes): 15	Surcharge Evidence? No Depth of Surcharge (ft): Depth of Silt (in):
Describe any potential hazards	<b>Real-time Readings</b> Level (in): 6.49 Velocity (fps): 2.45 Battery (volts): 6 Sensor Offset (in): Meter Running? No	Comments:
good steps but it is a big line so be careful.	Comments:
